PREVENTATIVE MAINTENANCE

Mitigate Against Air Conditioning System Malfunction

TECHNICAL REPORT

Project Information: Assessment of the air conditioning systems

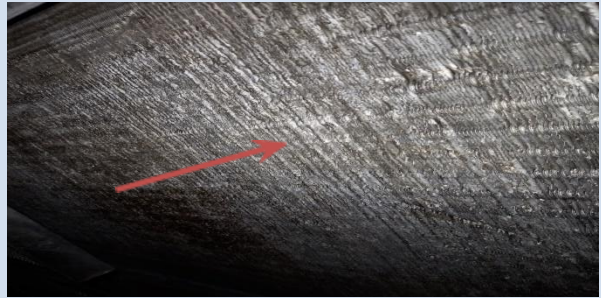
| Component | Observation | Risk | Recommendation | Supporting Image |
|---|---|---|---|---|
| Evaporator Coil | 50% deterioration. Heat transfer surface compromised | | Air Handler would be the most cost effective solution in the short term | |

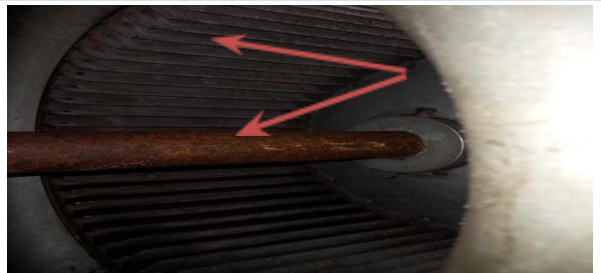
| Component | Observation | Risk | Recommendation | Supporting Image |
|---|---|---|---|---|
| Blower Wheels | Metal starting to deteriorate | | Short term blower wheel replacement required | |

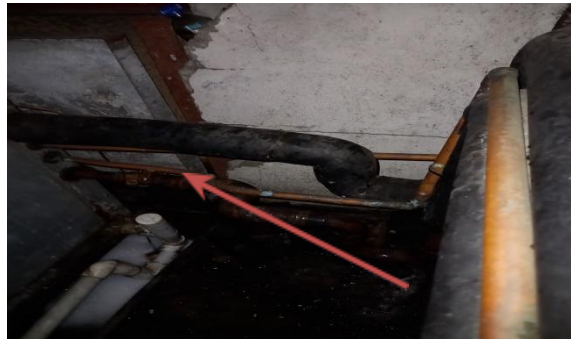
| Line Insulation | <p>Missing Insulation</p> <p>This can impact performance.</p> <p>Expansion valve bulb uninsulated – this will cause the valve to perform erratically and risk compressor failure</p> | | <p>Expansion valve bulb and suction line needs insulation</p> | |

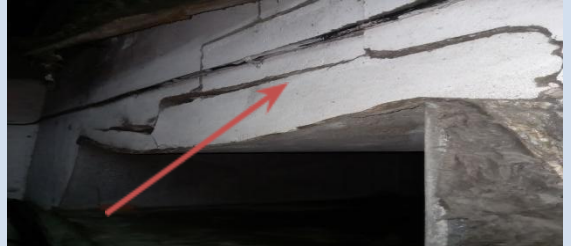
| Ducting | <p>Broken wall compromising return duct opening.</p> | | <p>Wall should be repaired and supported.</p> | |

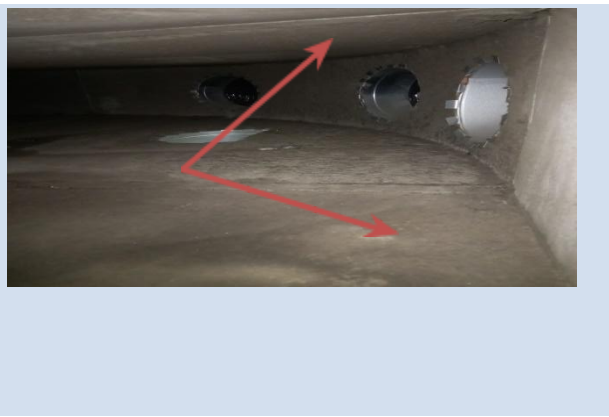
| | <p>Ducting is extremely dirty. This significantly affects the indoor air quality of the space and can lead human respiratory issues</p> | <p>Urgent Duct cleaning needed</p> | |

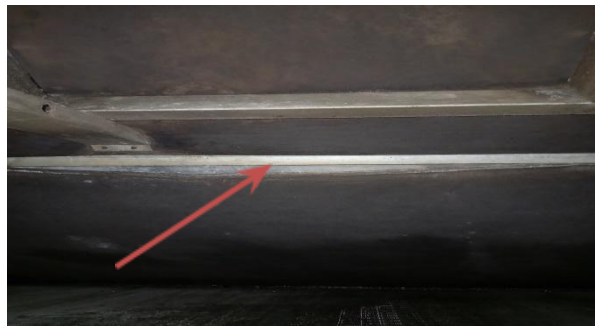
| <p>Panel Insulation</p> | <p>Insulation deteriorated and disconnected from panel</p> | <p>Insulation should be replaced ASAP</p> | |

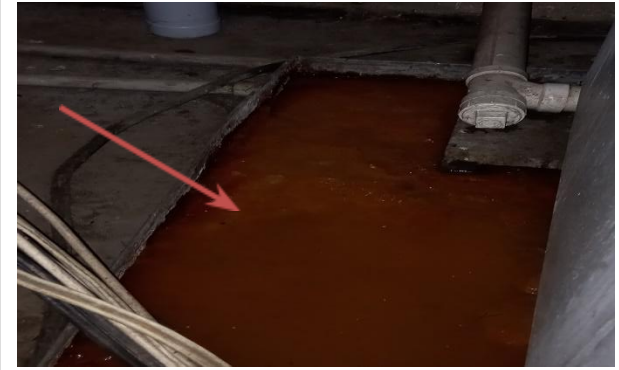
Secondary
Drain Pan

Significant fouling
and corrosion –

This is a health and
indoor air quality
concern

Drain pan servicing urgently
required

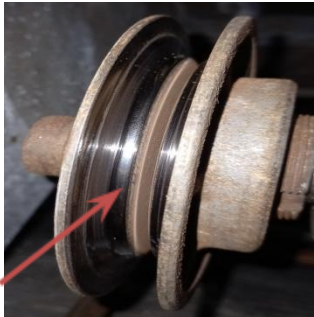
| Motor Pulley | Defective Pulley | Replace motor pulley | | |

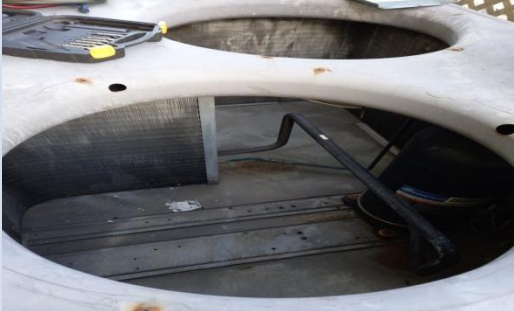
| Cond 2 | 2 fan motors and fan blades missing - Condenser coil also deteriorated | | Entire condensing unit should be replaced | |

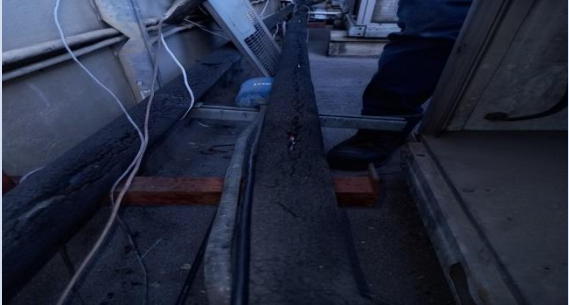
Line
Insulation

| Significant line insulation deterioration – | | Replace insulation when replacing entire condensing unit | |

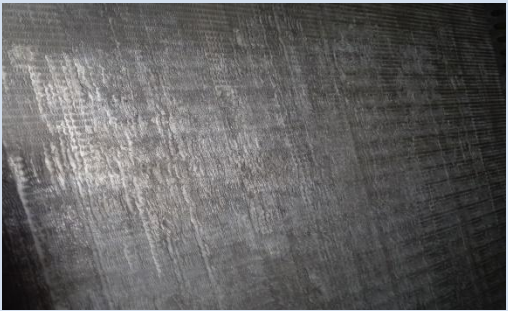
| Evaporator Coil | <p>40% Deterioration -</p> <p>This negatively impact system performance and increases energy consumption - ,</p> <p>Compressor placed at risk</p> | | Replace air handler in the short term | |

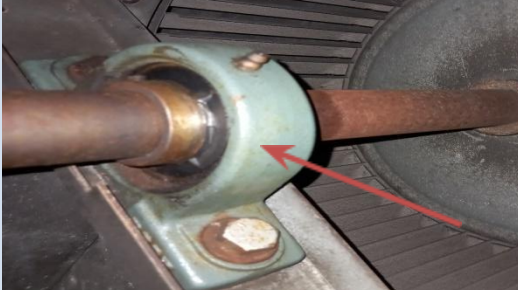
| Blower shaft Bearings | <p>Fair Condition</p> <p>Defective blower bearings -</p> <p>Risk of blower failure</p> | | Replace bearing ASAP | |

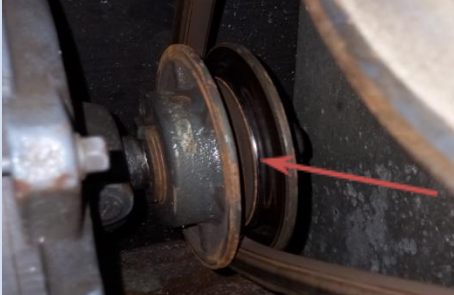
| Motor Pulley | Defective pulley – Risk of belt and motor failure | | Replace motor pulley ASAP | |

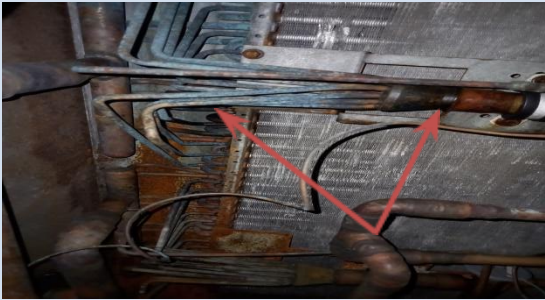
| Refrigerant pipe | Multiple refrigerant leaks observed | | Pressure test and repair all refrigerant leaks | |
